DuPont 2018 Field Analysis

PV Reliability

DuPont Global Field Reliability Program

2018 Global Field Data Analysis Summary

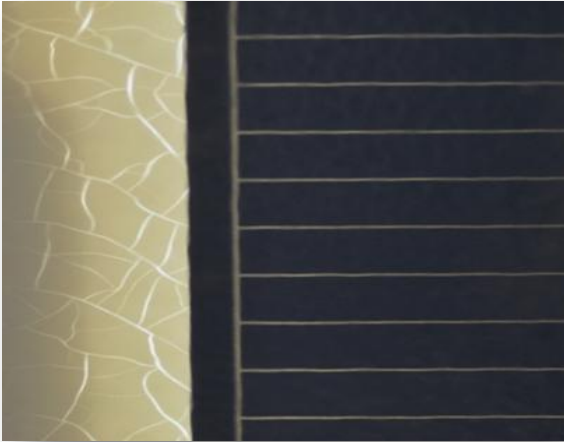
Inner Layer Cracking of PET Backsheet

- Backsheet inner layer cracked all over modules in spaces between cells and edges
- 30% power loss in 5 years, 6% loss per year
- Similar defects showing up in two continents

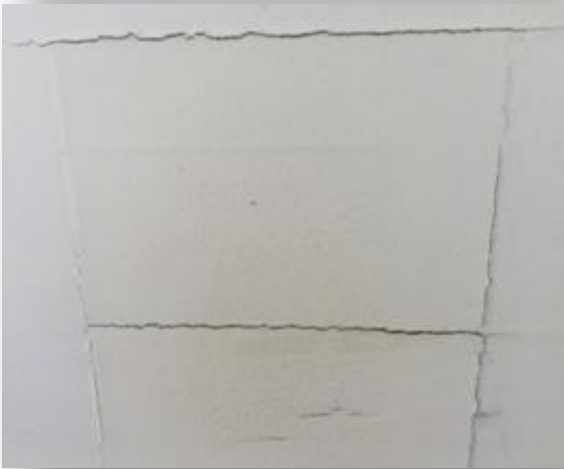
Outer Layer Cracking of Polyamide Backsheet

- Global failure estimated at >10 Gw
- 3-4 years service
- Safety issue and power loss due to inverter tripping
