Failures, fiascos and fires: How to avoid trouble from manufacturing, through design, to installation

Quality Roundtable – Solar Power International 2019

Materials choices to avoid field failures

Mysterious faults

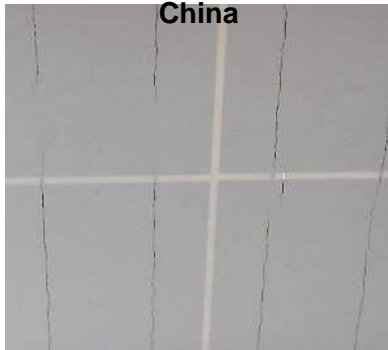
6 years, NW
China

Widespread backsheet through-cracks

- Prevalent along busbar ribbons, but extends to cell gaps and other regions with continued weathering
- Arcing and shorts often lead to localized burn-through and sometimes full module fires
- Reported inverter tripping and ground faults

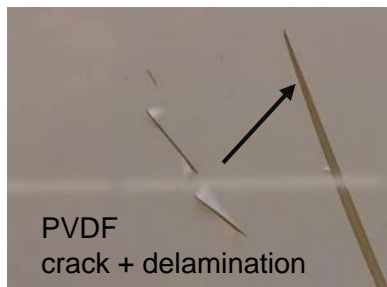
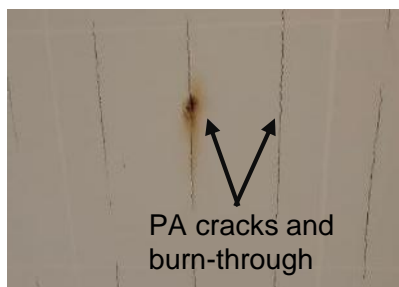
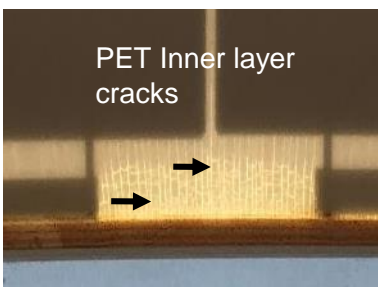
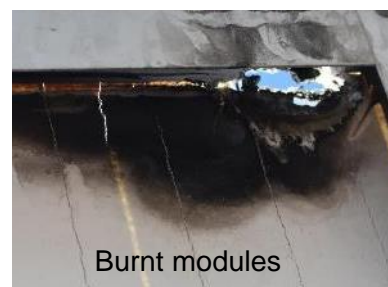
Illumination from rear to reveal cracks in the inner layer

- prominent near busbars

Multiple Bills Of Material (four types of backsheets revealed, possibly other components) in the same model number with mixed serial numbers from a single module maker (BS1: 50% of field, BS2, BS3, BS4: ~16% each)

Different backsheets degrade differently though all are qualified by IEC certification

- **Three backsheets degrade significantly while one is completely defect free**

All PVDF, PET, PA-based backsheets exhibited cracking

- 100% PA backsheets cracked along busbar ribbons, with several instances of burn-through
- 100% of PVDF backsheets have cracked outer layer leading to delamination
- 100% PET backsheets have cracked inner layer

Cracking facilitates moisture ingress, often leading to busbar corrosion

Exposure of module interiors to moisture leads to shorting, inverter trips, power loss, and several instances of module fires

Know your BOM!

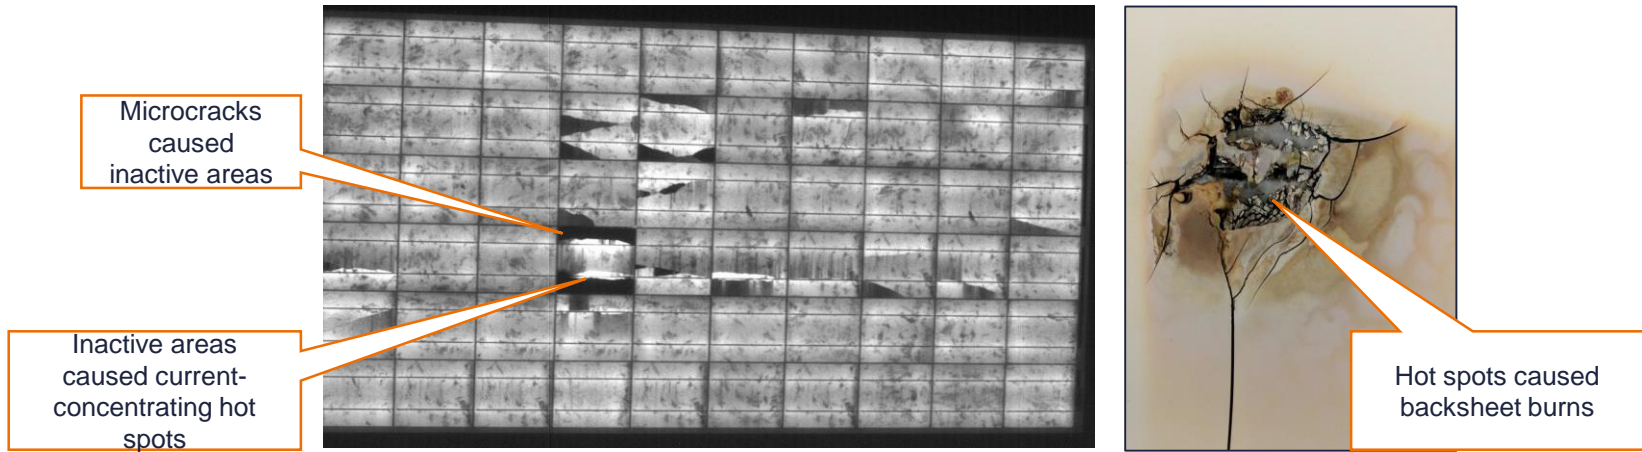
Issues observed after 5 years in field

- › Original owner sold the project to a third party in 2016
- › Microcracks soon began to cause hot spots and subsequent backsheet burns
- › **This created a safety hazard that had to be immediately remedied**

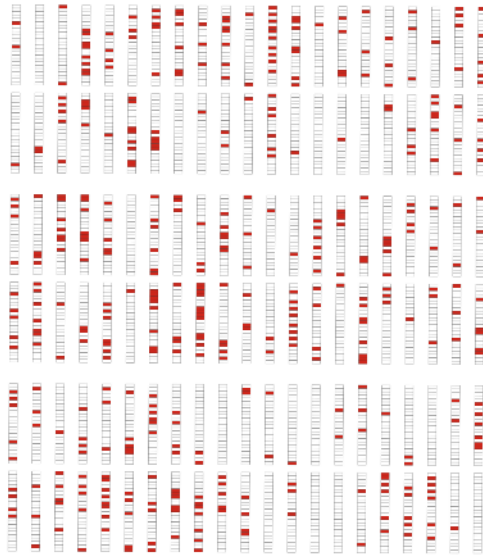
Module Batch #1
Source: Heliolytics

- › Owner conducts aerial thermal scan to quantify module defects
- › Half the site had excessive hot spots throughout; the other half had far fewer hot spots

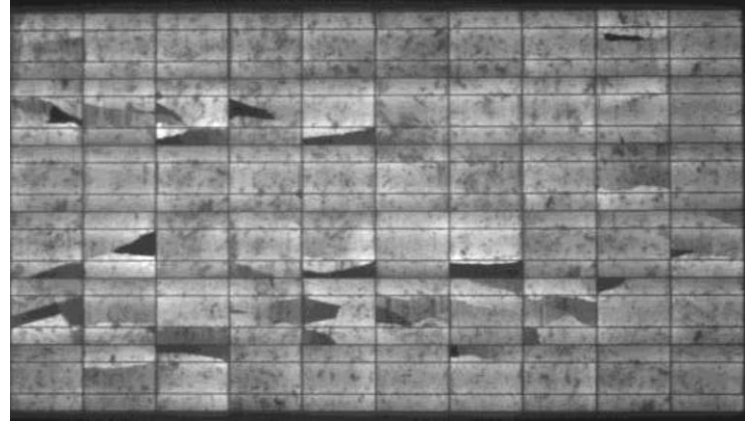
Post Thermal Cycling 200
Source: PVEL

- › In 2011, PVEL completed serial defect testing for a batch of modules used in project
- › EL images of most samples showed signs of excessive microcracks originating at the cell bus bars, pointing to a soldering-related root cause
- › Thermal cycling caused the potential power loss to be realized
- › **PVEL's results were not fully considered and the module installation proceeded**

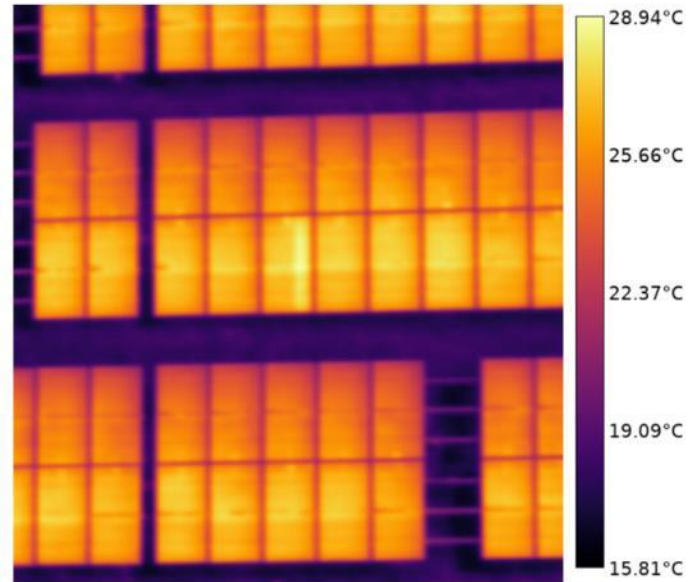
A routine aerial inspection was performed on a utility scale PV project. Based on initial findings, it was seen that approximately 0.2% of the site exhibited sub-module faults. This level of faults places the project in the 20th percentile of projects, meaning that 80% of comparable projects would have a fault rate less than this amount, indicating a potential warrantable issues.

Figure 1: Example of a sub-module defect seen from aircraft IR caused by diode activation or solder bond failure

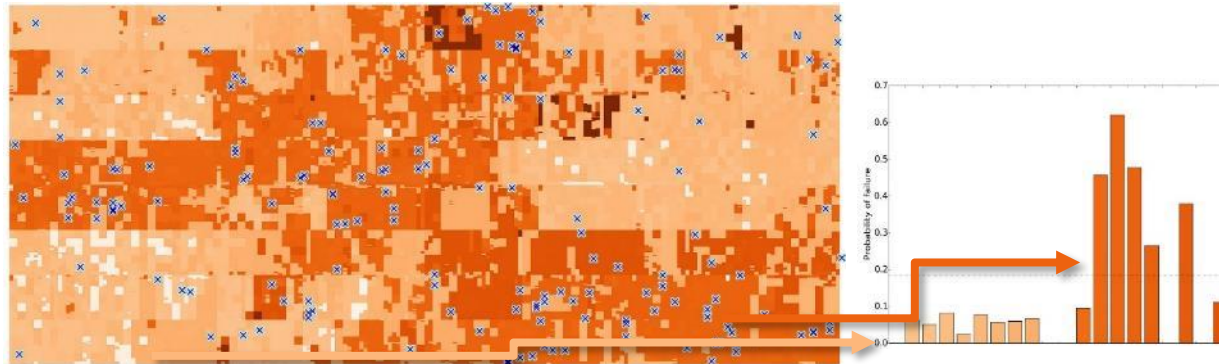
Figure 2: Serial number correlation analysis, showing a correlation between diode faults (x) and serial number batch (shade of orange). The bar graph shows the difference in probability of failure between the light orange and dark orange serial number bins.

It can be seen that the location of sub-module faults correlated with a specific subset of serial numbers on site. Upon further investigation of the identified serial numbers, it was seen that all affected modules came from the same plant, production line and soldering machine. Upon further investigation with the manufacturer, it was identified that a soldering machine was out of calibration during manufacturing, affecting 1/5 of the modules on site.

In this specific case, this information allowed the customer to better identify underlying risks in the project, and to negotiate a more beneficial settlement to the warranty for these modules, which included a consideration for the potential of future module failures.
